**MORE THAN A DECADE OF EXPERIENCE**  
**WITH**  
**CONTINUOUS FALCON CONCENTRATORS**  
**AT**  
**THE TANTALUM MINING CORPORATION OF CANADA'S**  
**LAC DU BONNET OPERATION**

**Claude Deveau, P. Eng.**

**Chief Metallurgist**

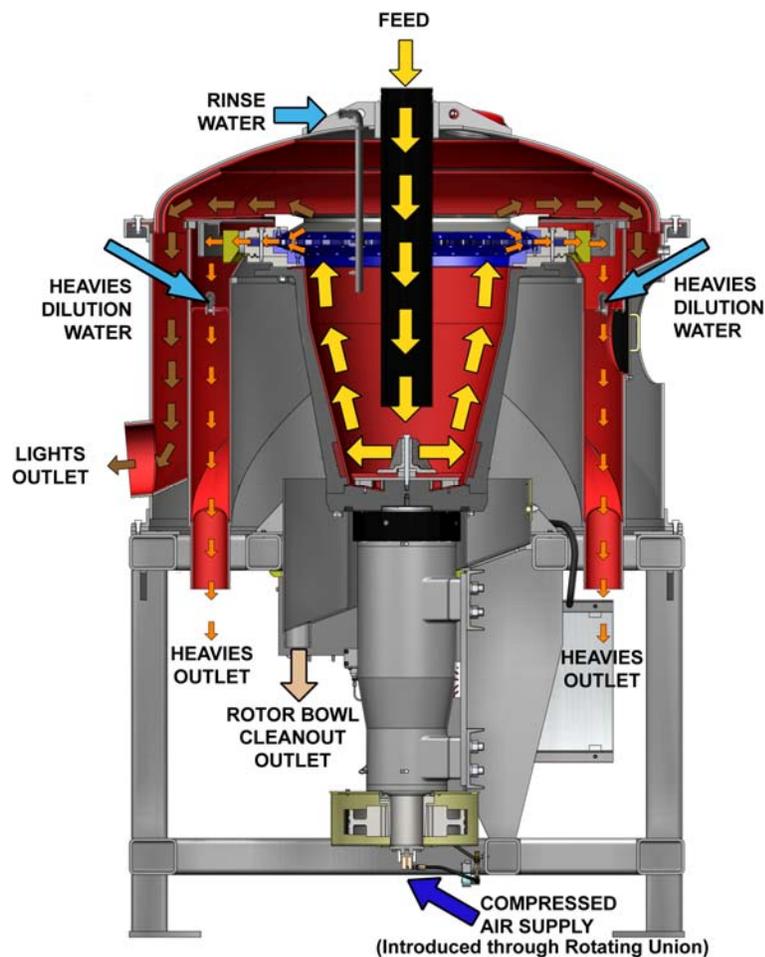
**Continuous Falcon Concentrator**

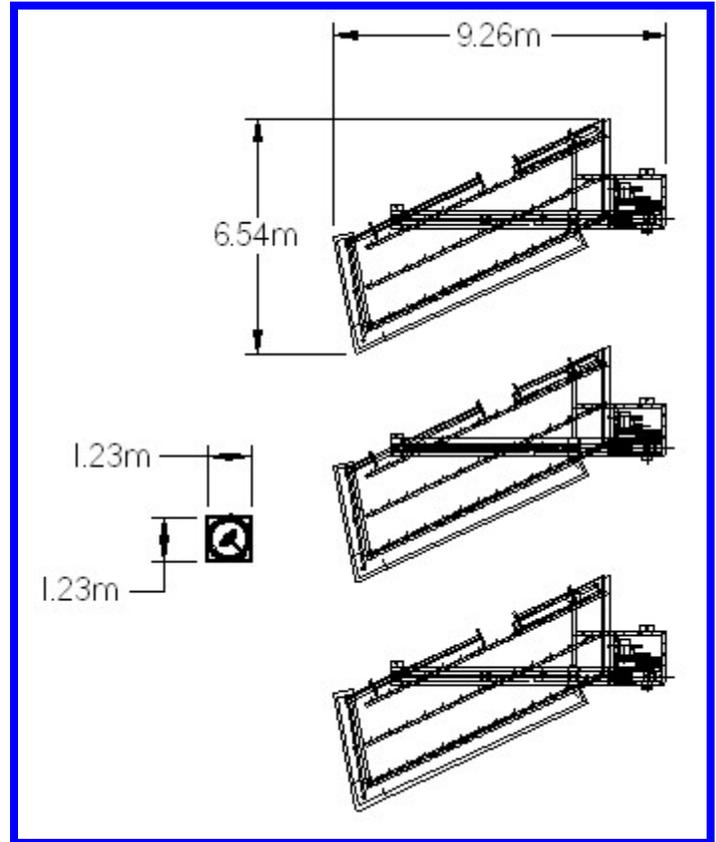
**Figure 1: Floor Space Comparison:  
C400 vs. 3 Double Deck Shaking  
Tables**

Success with the C1000 led to purchase of a smaller machine to clean concentrate from the C1000. The smaller machine was the predecessor of today's Model C400 Falcon Concentrator. The table in Figure 5 clearly shows the benefit of using a 2-stage approach. Both recovery and grade were improved. The C400 replaced 6 Holman tables (3 double deck) that require approximately 750 ft<sup>2</sup> of floor space. A C400 requires 25 ft<sup>2</sup> (5' X 5'). Figure 1 shows a scale representation of the Falcon C400 vs three double deck Holman tables. The new C400 was installed at Tanco in September of 1998.

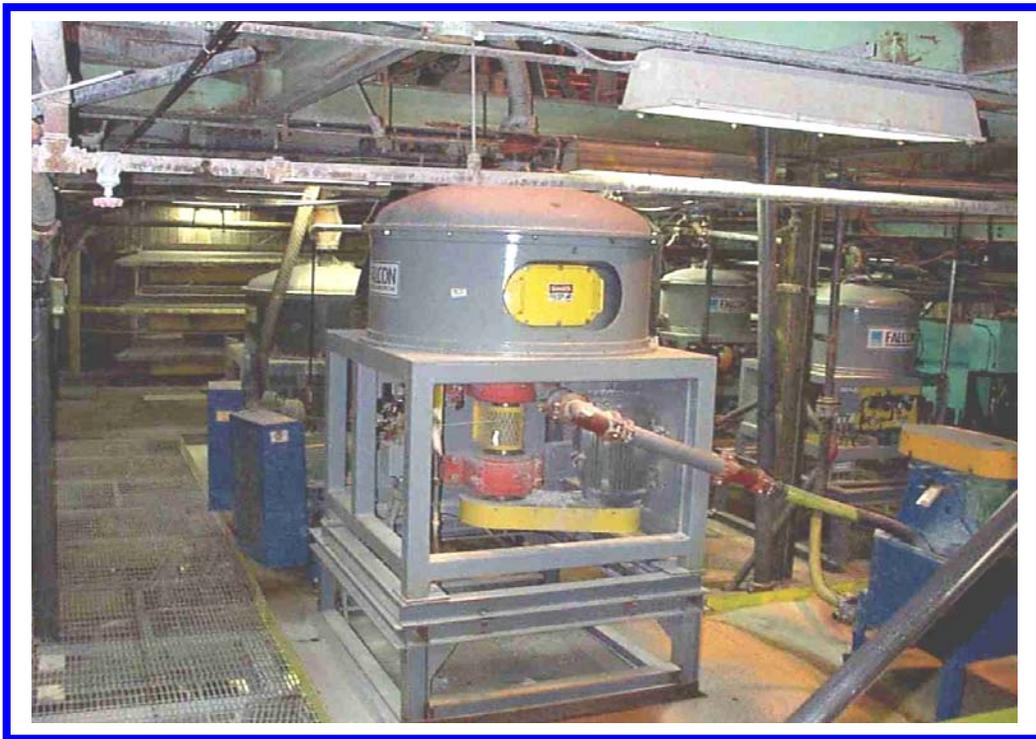
**Fig 2: Four Continuous Falcons in Operation at Tanco.**

Tanco is unique in the fact that it has ability to operate 3 separate processes for 3 very distinct minerals at one site. The initial installation of Falcons (C1000 & C400) was completed on the tantalum circuit. Tantalum is also recovered as a by-product within the Spodumene operation. This led to trials with the Falcons on this circuit as well. Several trials were completed with the continuous Falcons from the Tantalum circuit on a targeted stream from the Spodumene circuit. Results showed that payback time for a similar installation was relatively short. A new C1000 and C400 were purchased and installed in order to recover Tantalum from the Spodumene circuit in November 1999.

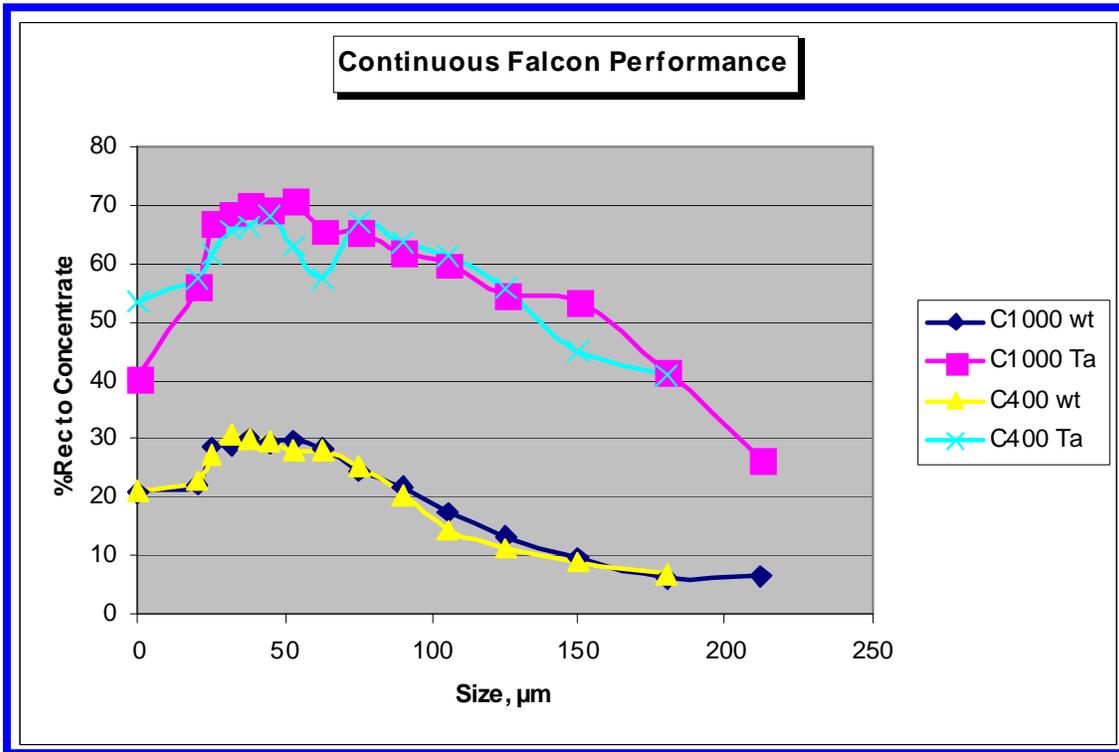
**Figure 4: Typical Continuous Falcon Performance in Fresh Feed Application treating Tantalum.**

In Figure 4, we see an application with fresh feed to the continuous Falcon. In this case, adequate recovery extends past 150µm where locking then becomes an issue.

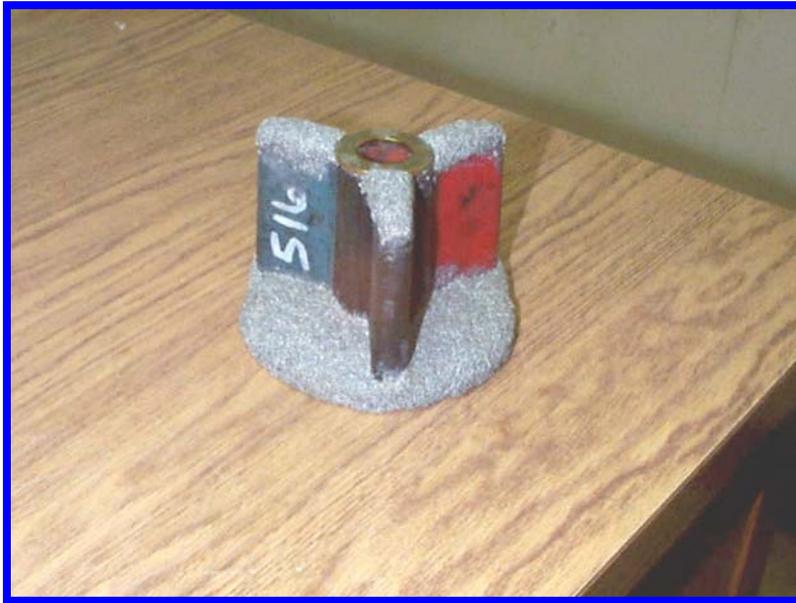
**Fig. 7: Test Impeller  
(Provided by Sepro)**

C400 Flow Channel Liners	>12,000	C400 channel liner life is approximately 2 yrs at Tanco.
C1000 Impellers	~6,000	In the beginning, impeller life was short at merely two weeks (300 hrs). After a material compatibility study was completed, lined impellers for Falcon C1000's had a life of approximately 6000 hrs. See Fig 7, 8, 9.
C400 Impellers	~40,000	It has been found that impellers for C400's last well over 5 years.

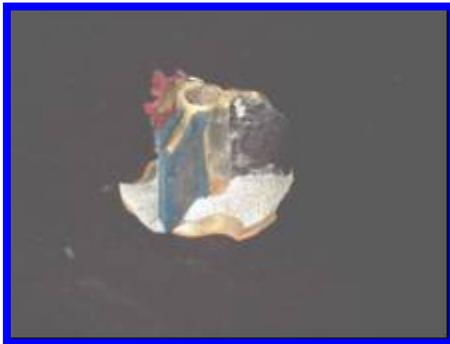
**Fig. 8: After 1 Year of Operation...**

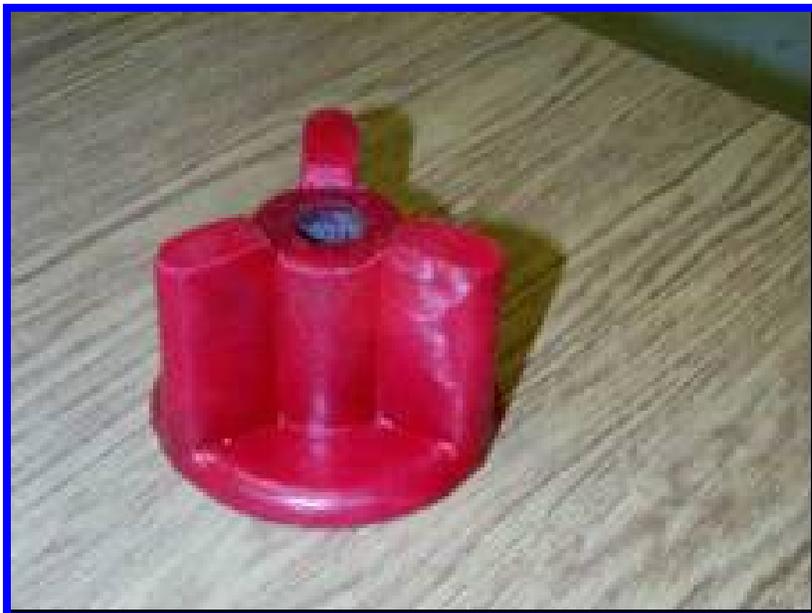
**Fig. 9: Optimized Impeller**

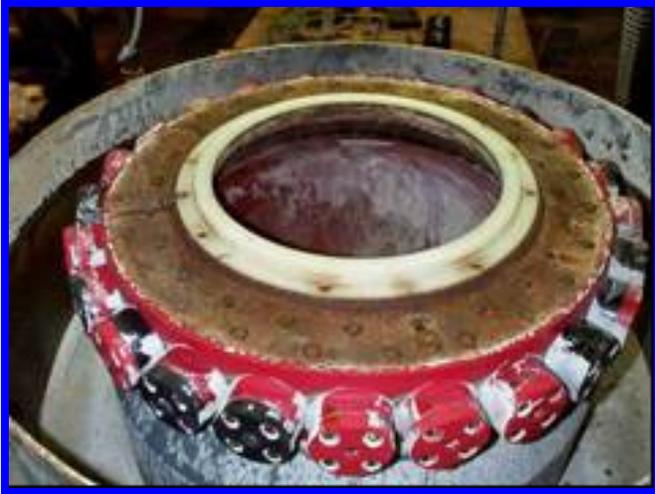
**Fig 10: Plastic head and valve bodies. (1997)**

Valve Bodies	<p align="center">&gt;40,000</p>	<p>Valve bodies currently have lives that can exceed 5 years. Valve body design has dramatically evolved in the recent years. Forces in excess of 300g's are exerted on these parts as they are bombarded by very abrasive slurry. Design changes were also made to the concentrate launder in order to divert the flow of slurry away from the valve bodies. The current design has all but eliminated valve body wear due to abrasion. When the valve body life was extended due to the elimination of abrasion, bond failures within the valve began to occur through fatigue. This problem has also been rectified.</p>

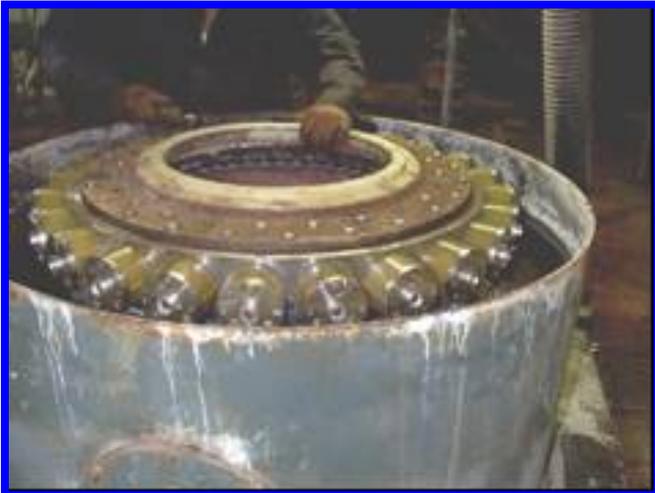
**Fig 11: Stainless steel head with new design of valve bodies. (1999)**

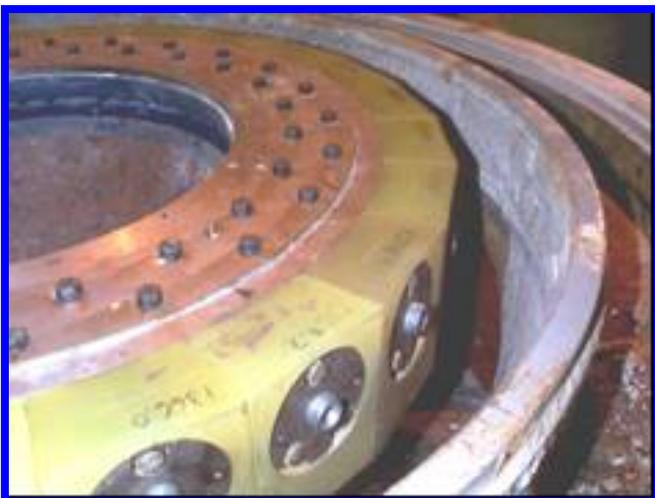
**Fig 12: New Aerodynamic valve design. (Circa 2005)**

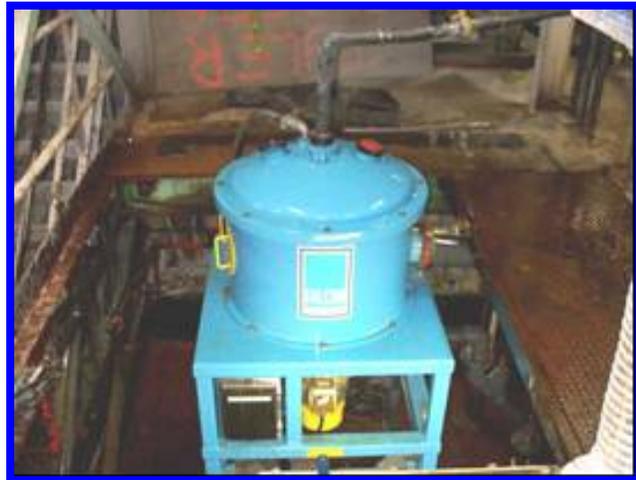
**Fig 11: Newly installed UF600**

demonstrated its superiority to the existing technology. Soon after, a similar, but larger rotor was designed and installed on the platform of a larger Falcon. Although testing a larger concentrator allowed Tanco to study important aspects of the process including how the bed material collects in the retention zone, results were inferior to the initial prototype. Having understood the potential of these tests, Sepro provided another smaller prototype that allowed Tanco to study the bed formation in more detail. This model was based on Sepro's L40 platform. It was during use of this model that the concept of a moveable discharge lip was developed. With the help of performance data generated at Tanco, the UF600 was constructed by Sepro and installed at Tanco in April of 2005.

After further tests, the UF600 was adapted to multi-stage operation where one machine is used for a four-stage operation. This was accomplished using agitated tanks, pumps and valves supplied by Tanco. The system was controlled by a PLC supplied and programmed by Sepro.

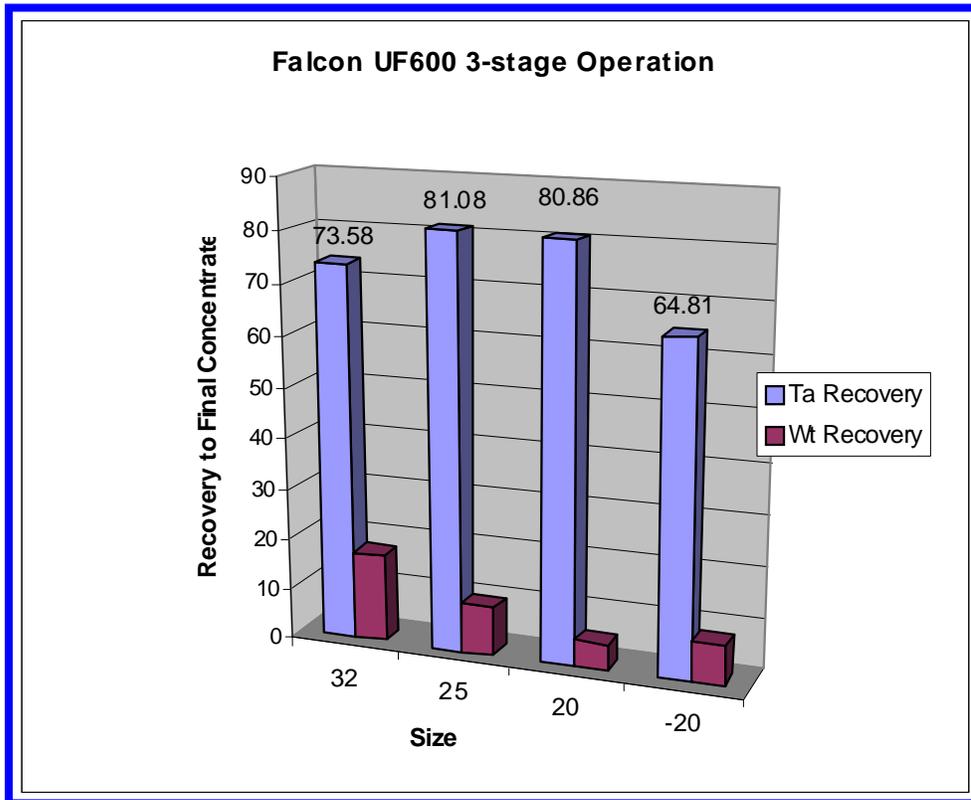
Fig 14. Falcon UF600 Performance with 3-stage operation

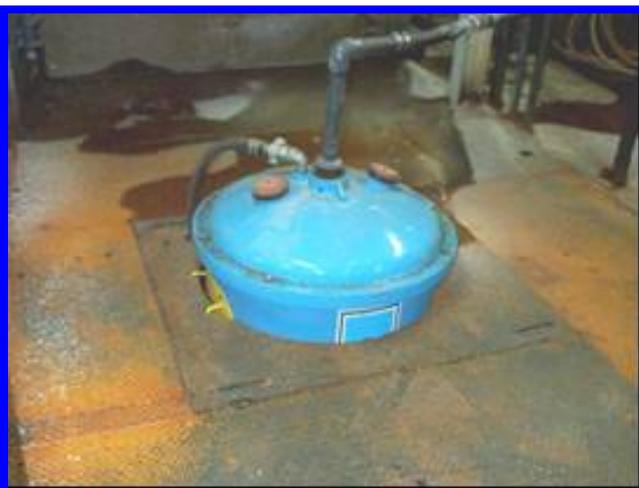
After over 23,000hrs of operation, the only parts that have required replacement are a rotating union and one impeller.

Fig 15: Note special attention to ergonomics for easy access.
